Rapid Erosion of a Southern California Beach Fill

Richard Seymour, Robert Guza , William O'Reilly
*Integrative Oceanography Division, Scripps Institution of Oceanography
University of California, San Diego, La Jolla, CA, 92093.*

ABSTRACT

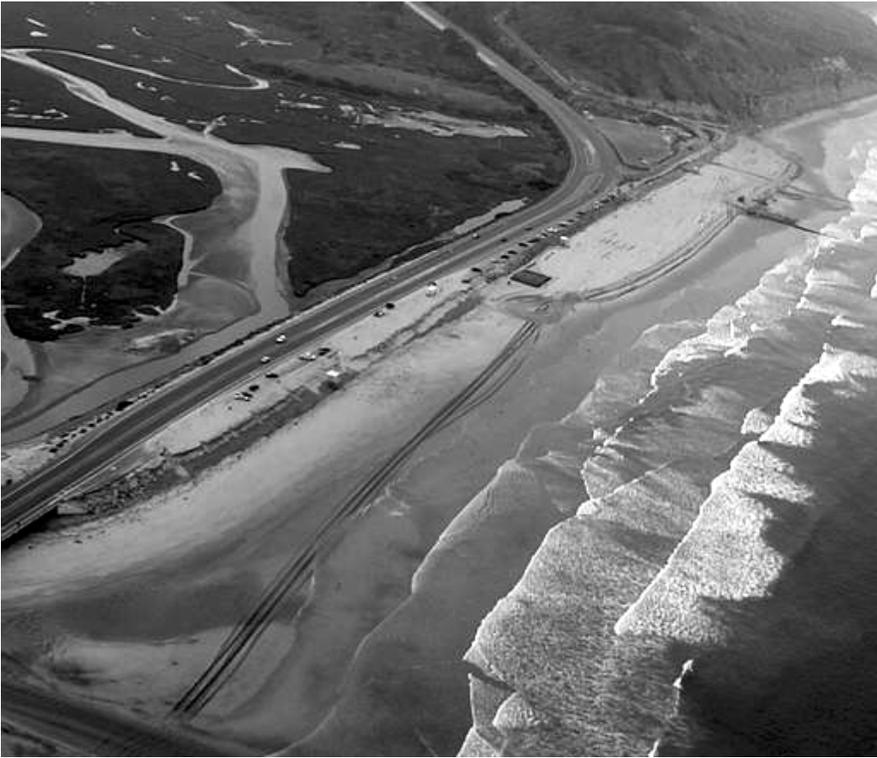
Figure 2. View of the beach fill site showing the Torrey Pines cliffs to the south and the lagoon mouth to the north.

area of low relief (see Figure 2.) The California Resources Agency and the Department of Boating and Waterways selected Scripps Institution of Oceanography (SIO) to undertake a detailed monitoring investigation of the Torrey Pines site. Surveys, as described in the following sections, were begun just prior to the fill construction and were continued biweekly for approximately one year and then monthly for an additional year. Sediment analyses of the native beach material and periodic sampling of the nourishment material were accomplished by others.

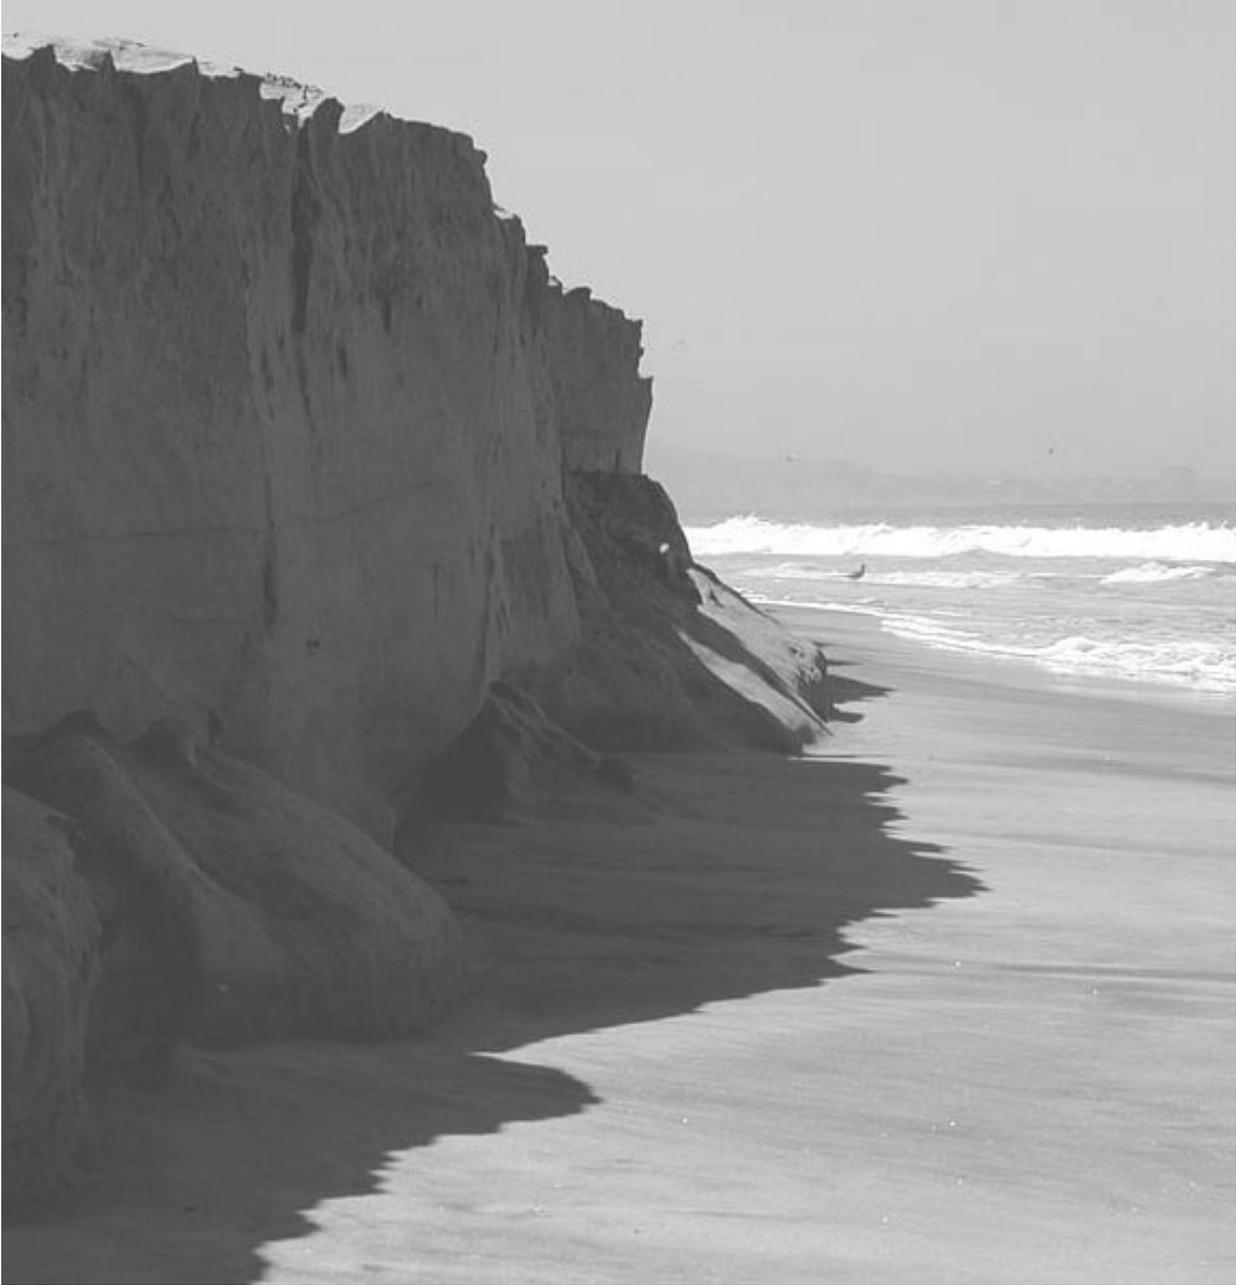
Figure 3. Post-construction scarp at Torrey Pines beach fill.

The Torrey Pines nourishment contained approximately 140,000 m³ of sediment with a median diameter (D₅₀) for the various samples that ranged from 0.15 to 0.25 mm. The native beach D₅₀ was xx mm, such that [comments on suitability]. The alongshore extent was approximately 750m and the width about 70m. This volume is relatively small compared to many East Coast beach fills. For example, in 1992 Florida constructed almost 200 km of nourishment in a total of 33 projects or an average of about 6 km per project (Clarke, 1992.) Because of its short length this project could be expected to suffer large end losses (Dean and Yoo, 1992.) Beach nourishment initial or as-built geometries typically result in slopes much steeper than the native beach slope so that construction operations can be accomplished in the dry, for the most part. At Torrey Pines, the native beach was very narrow – less than 80 m from a riprap seawall protecting the adjoining highway to the mean sealevel line. Rather than burying the riprap wall and sloping the fill to the shoreline, the contractor elected to level the fill material such that a steep, almost vertical scarp almost 2m high was formed near the shoreline (see Figure 3.) The construction required about 2 weeks and was completed in the last week of April, 2001. The scarp was maintained with very little modification by waves and tides for a period of about 7 months.

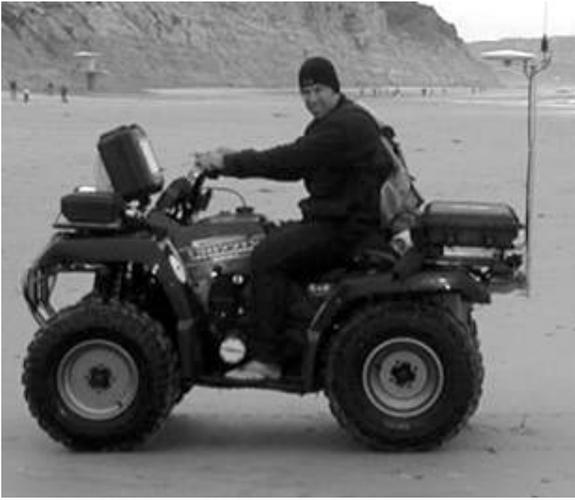
Figure 6. GPS-navigated all-terrain vehicle for dry beach surveys.

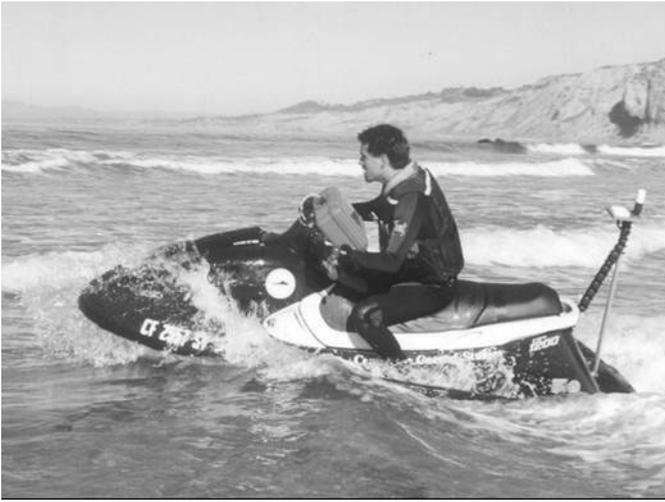
Figure 7. GPS-navigated JetSki for underwater surveys

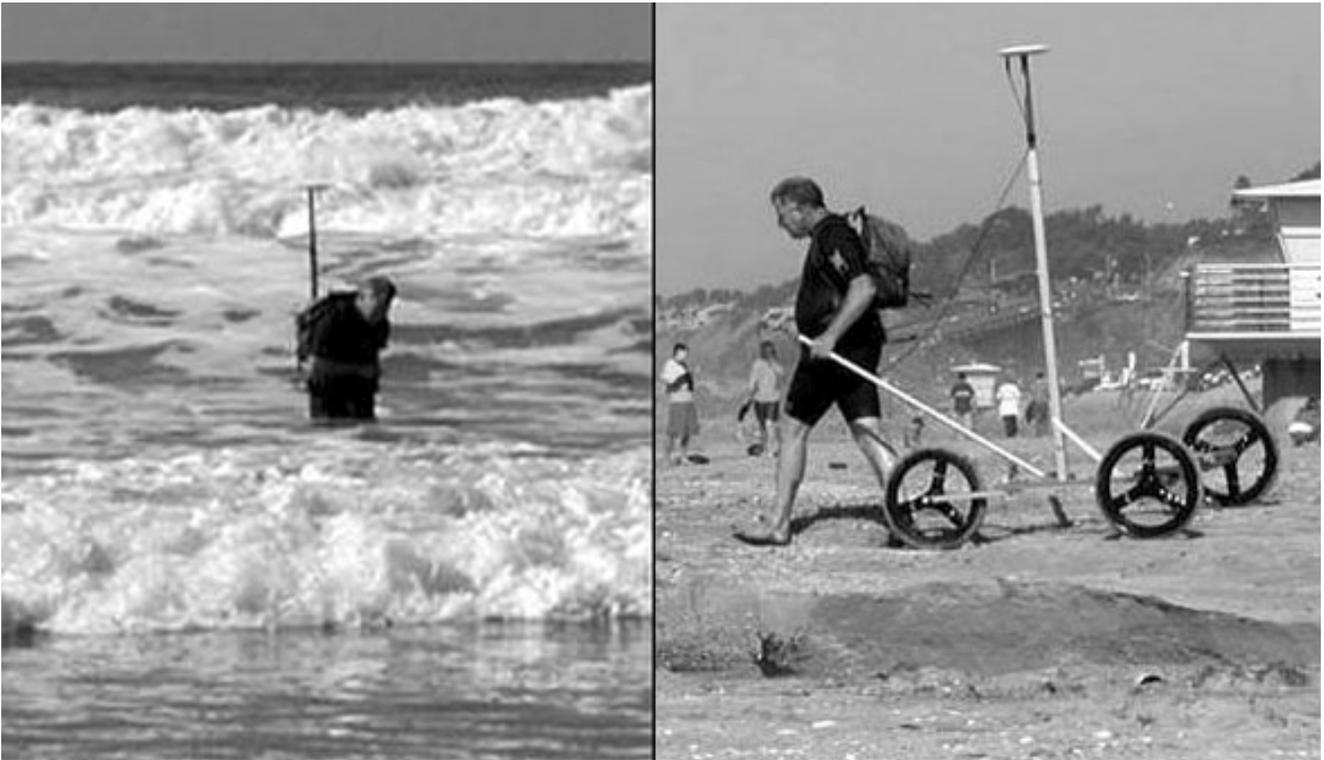
Figure 14. Survey activities during the storm using backpack (left) and dolly (right)

The beach fill began significant erosion early on Thanksgiving Day, November 22, 2003 – although the first visual observation by project personnel was not until the afternoon. The combined tide and runup overtopped the fill berm. Profile lines were run during daylight hours that day using GPS survey equipment contained in a backpack or mounted on a hand-propelled dolly (see Figure 14.) A full post-storm survey was completed a week later using the conventional equipment described above. As shown in Figure 15, the erosion was marked by a series of embayments which were spaced roughly 50m apart. Erosion of the intervening cusp-like material occurred at a slower rate than observed in the embayments. Figure 16 shows a sequence of pictures illustrating the erosion of one of the projecting features during a single wave uprush event. Although similar patterns of berm erosion have been observed elsewhere (Inman, 2002), there is no available theory to explain the quasi-periodic character of the embayment

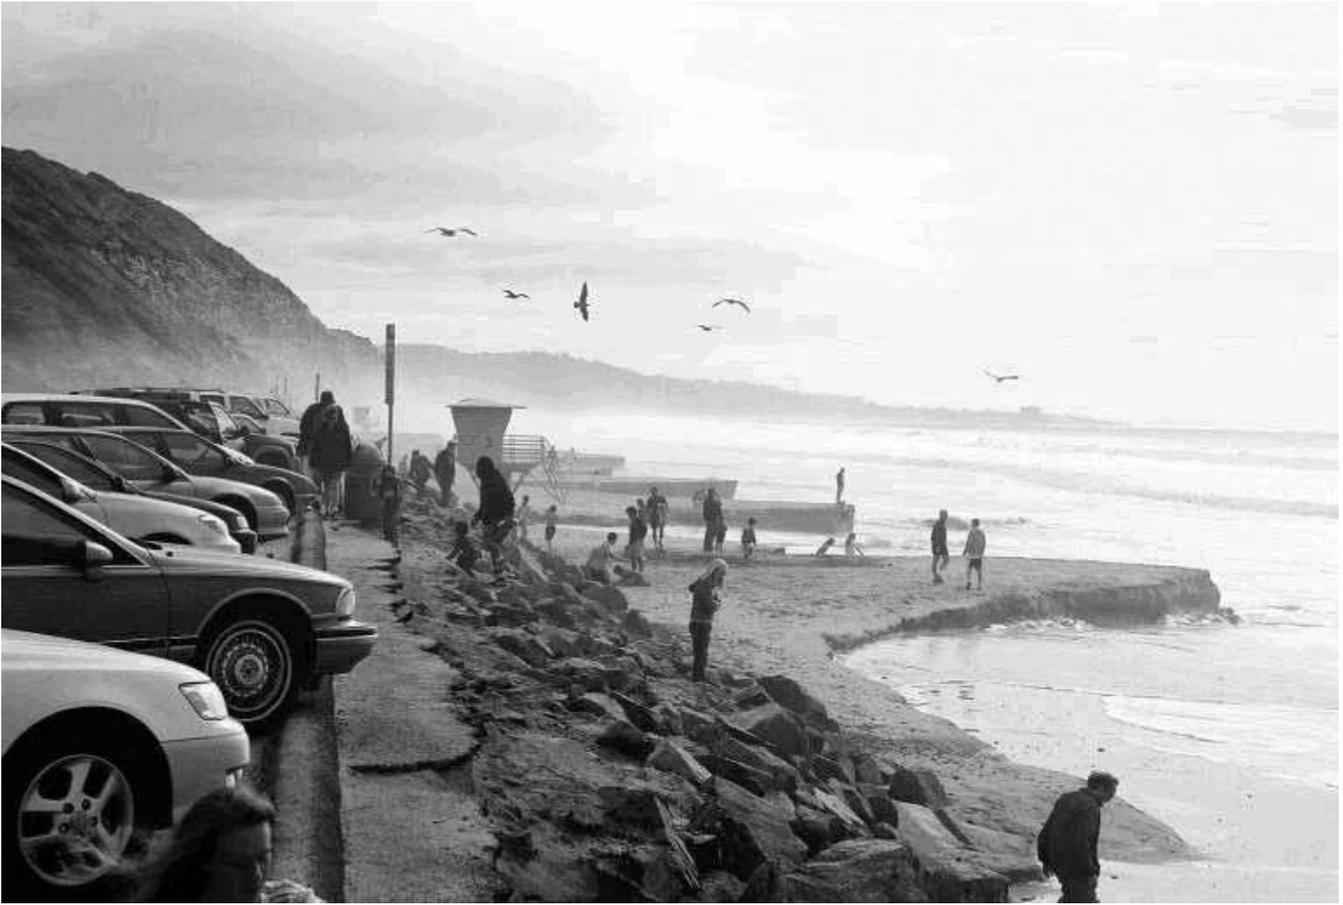
Figure 15. Beach fill erosion as a series of embayments

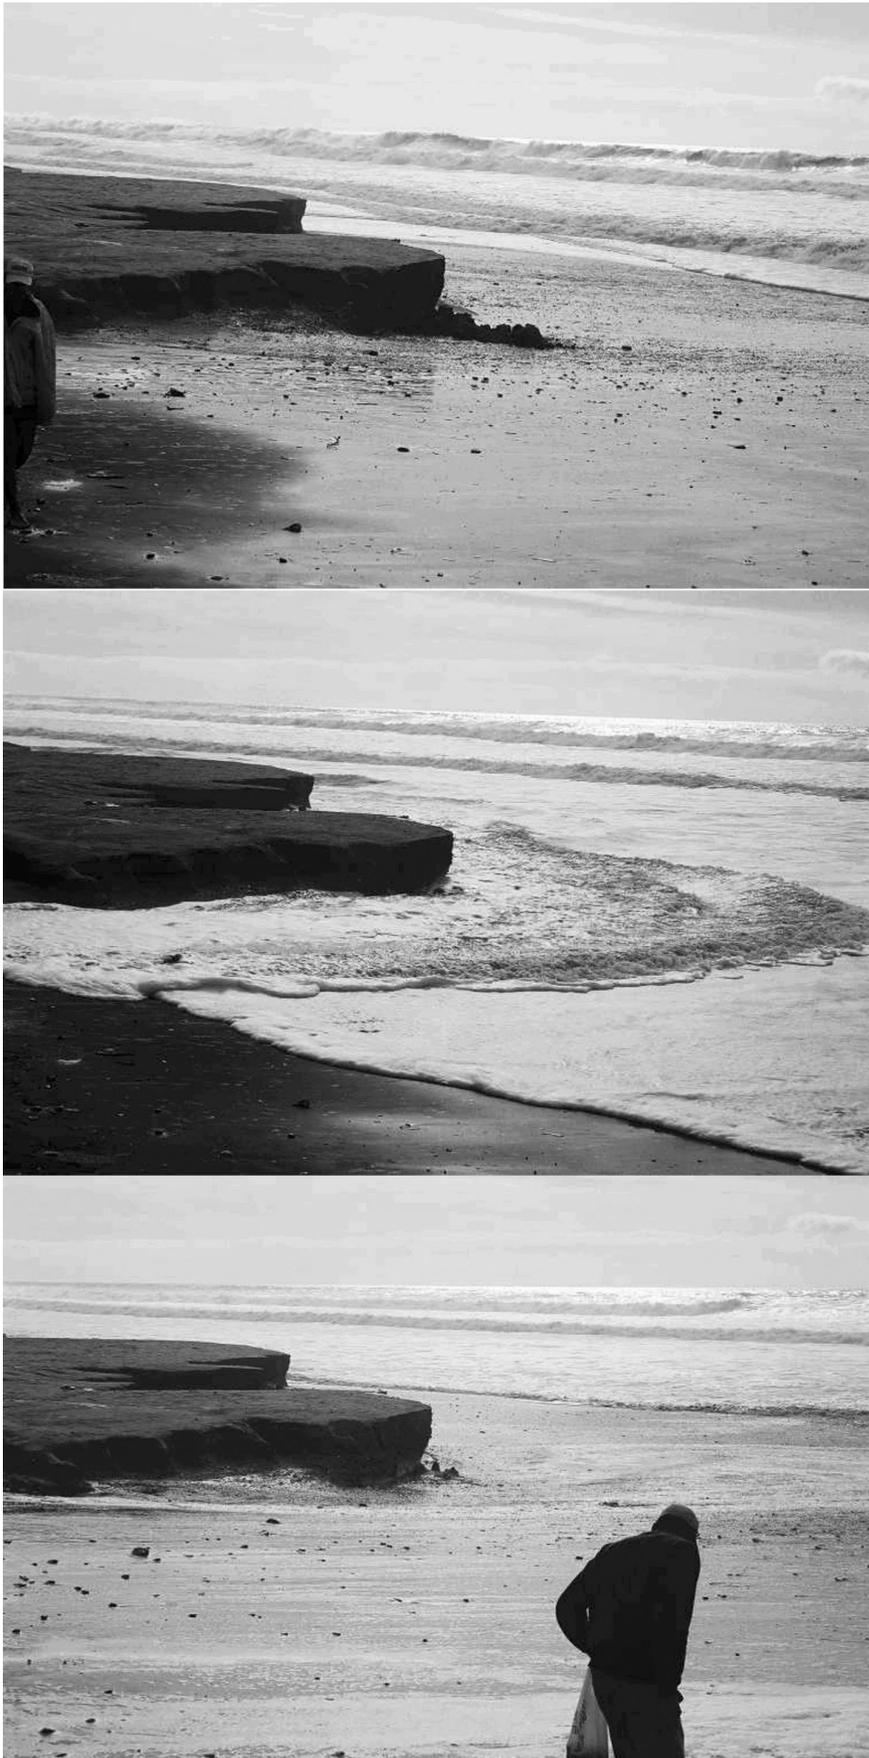
Figure 16. Sequence over one wave period showing erosion of the tip of a cusp

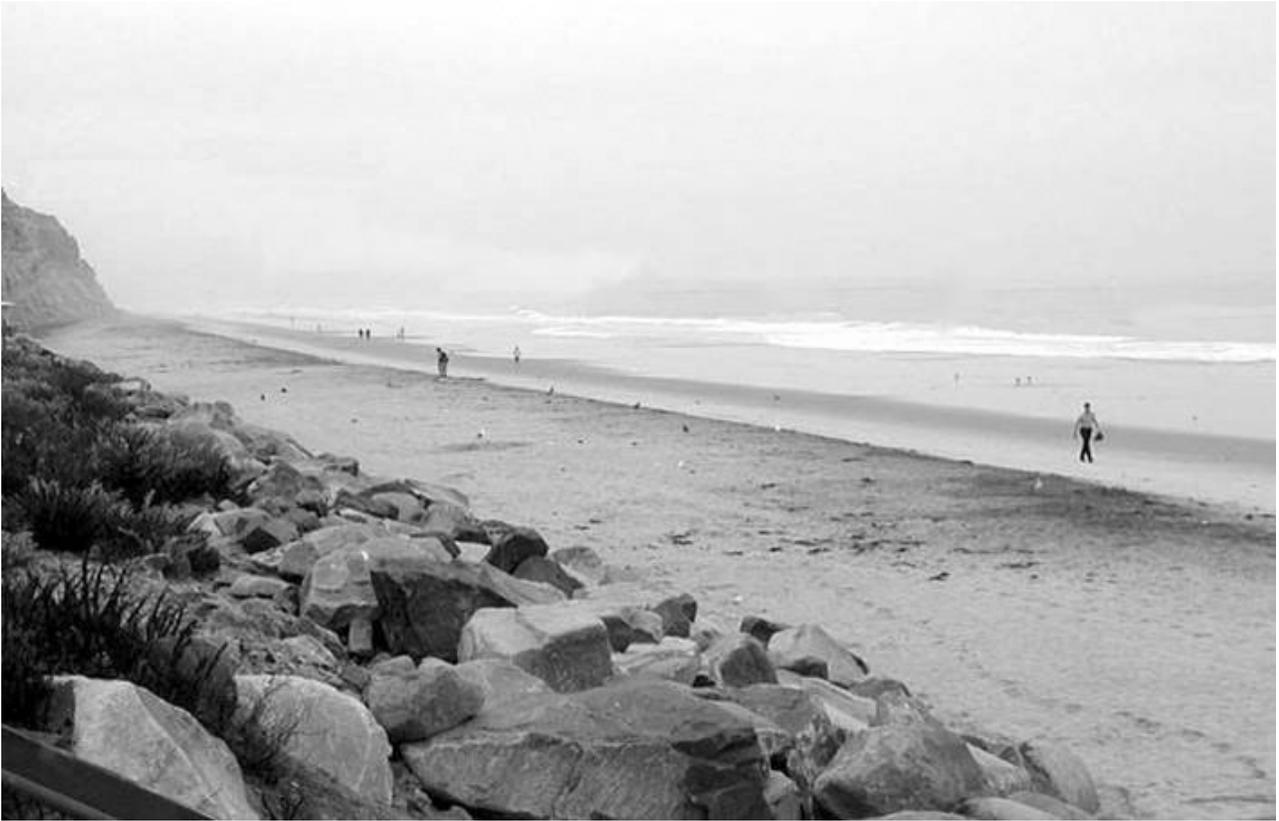
Figure 18. Summer beach at the site of the fill in 2002, the year following the storm

formation. By daylight on November 23, the fill had been almost completely eroded to the riprap revetment at the back of the beach. Figure 17 shows the changes in the beach elevation that occurred between the surveys of 17 November, 2001 (pre-storm) and 30 November, 2001. Beach erosion exceeded 3m and the offshore accretion exceeded 1m. The location of the center of mass of the bar southward of the center of the fill is consistent with wave direction during the storm. The second offshore bar to the north of the fill is probably from the lagoon delta erosion. Figure 18 shows a view of the fill site during the following summer of 2002. Although the beach recovered to a near-normal configuration, there was essentially no visual evidence of the fill location.
